METALLURGICAL TESTING

METALLURGICAL EXAMINATION OF ONE (1) WELD OVERLAY WEAR PLATE SAMPLE

Order No.	NA
Specimen Description:	320N25
Weld Overlay Material Specification:	NA
Testing Document:	NA

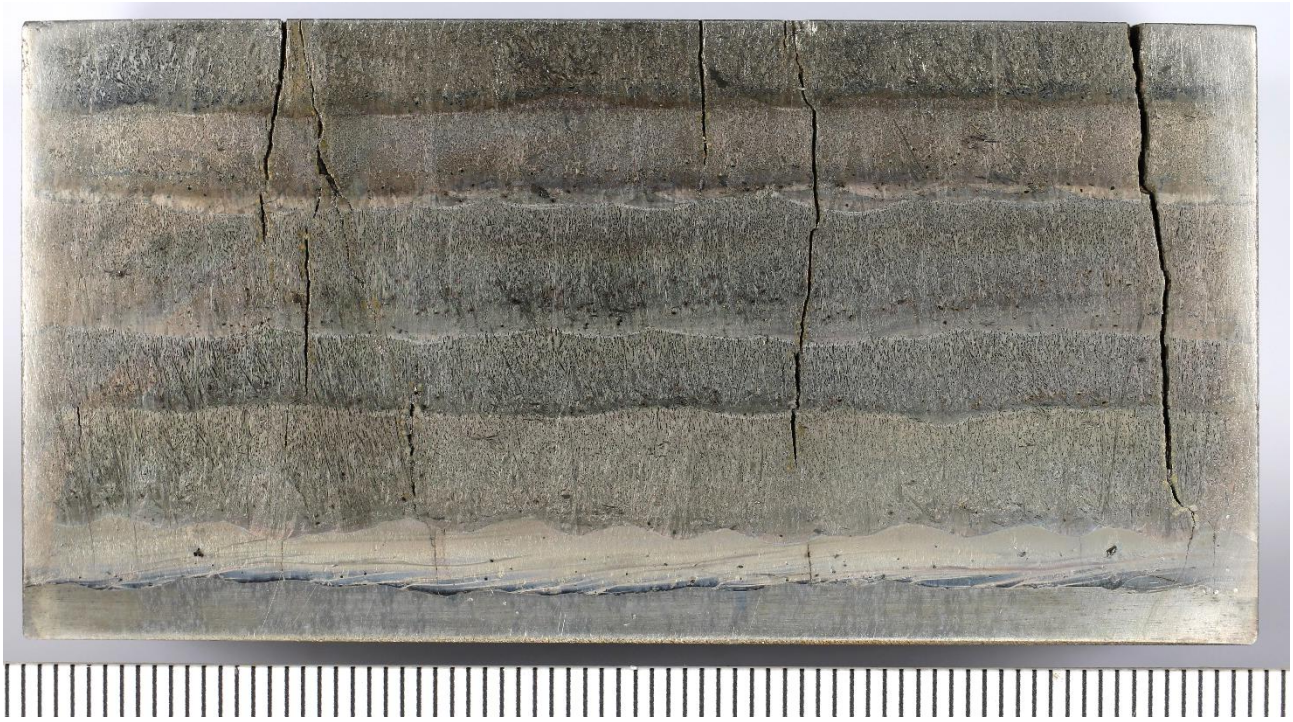
The sample exhibited satisfactory fusion with the substrate and absence of fusion defects. Stress relief cracks were evident through to the thickness of the weld overlay (Figure 1). Table 2 shows the plate total thickness, weld overlay thickness and number of hard facing weld layers.

Figure 1. Macrograph of the specimen cross-section showing sound fusion to the substrate along the weld overlay (scale in mm).

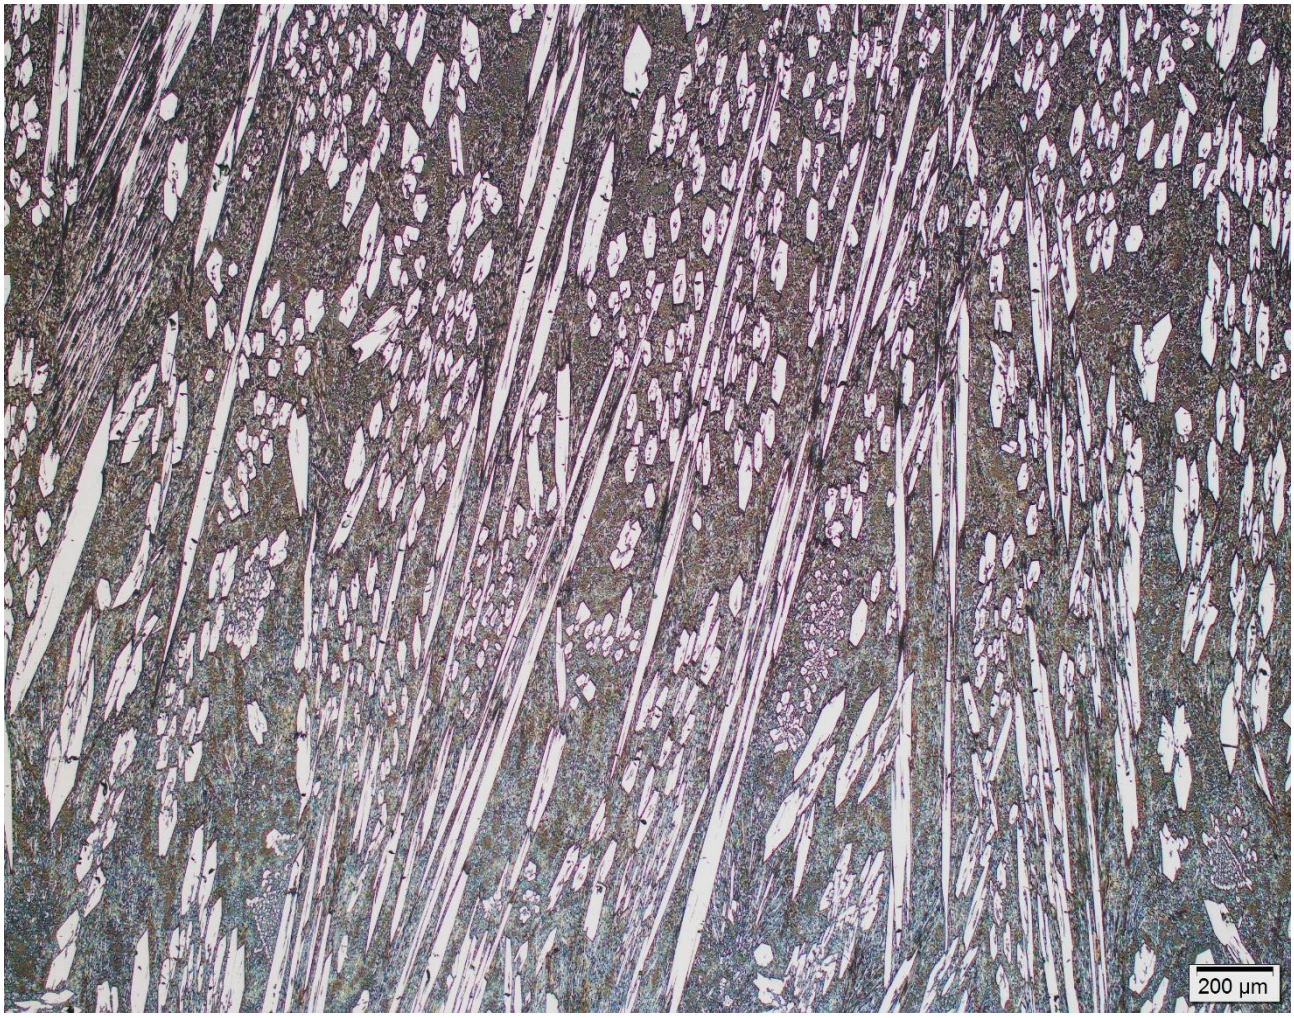
The microstructure of the weld overlay was seen to consist of primary carbides distributed throughout a matrix of eutectic carbides and austenite (Figures 2 - 3).

Figure 2. Typical weld overlay microstructure consisting of primary carbides in a matrix of austenite & eutectic carbides (low magnification).

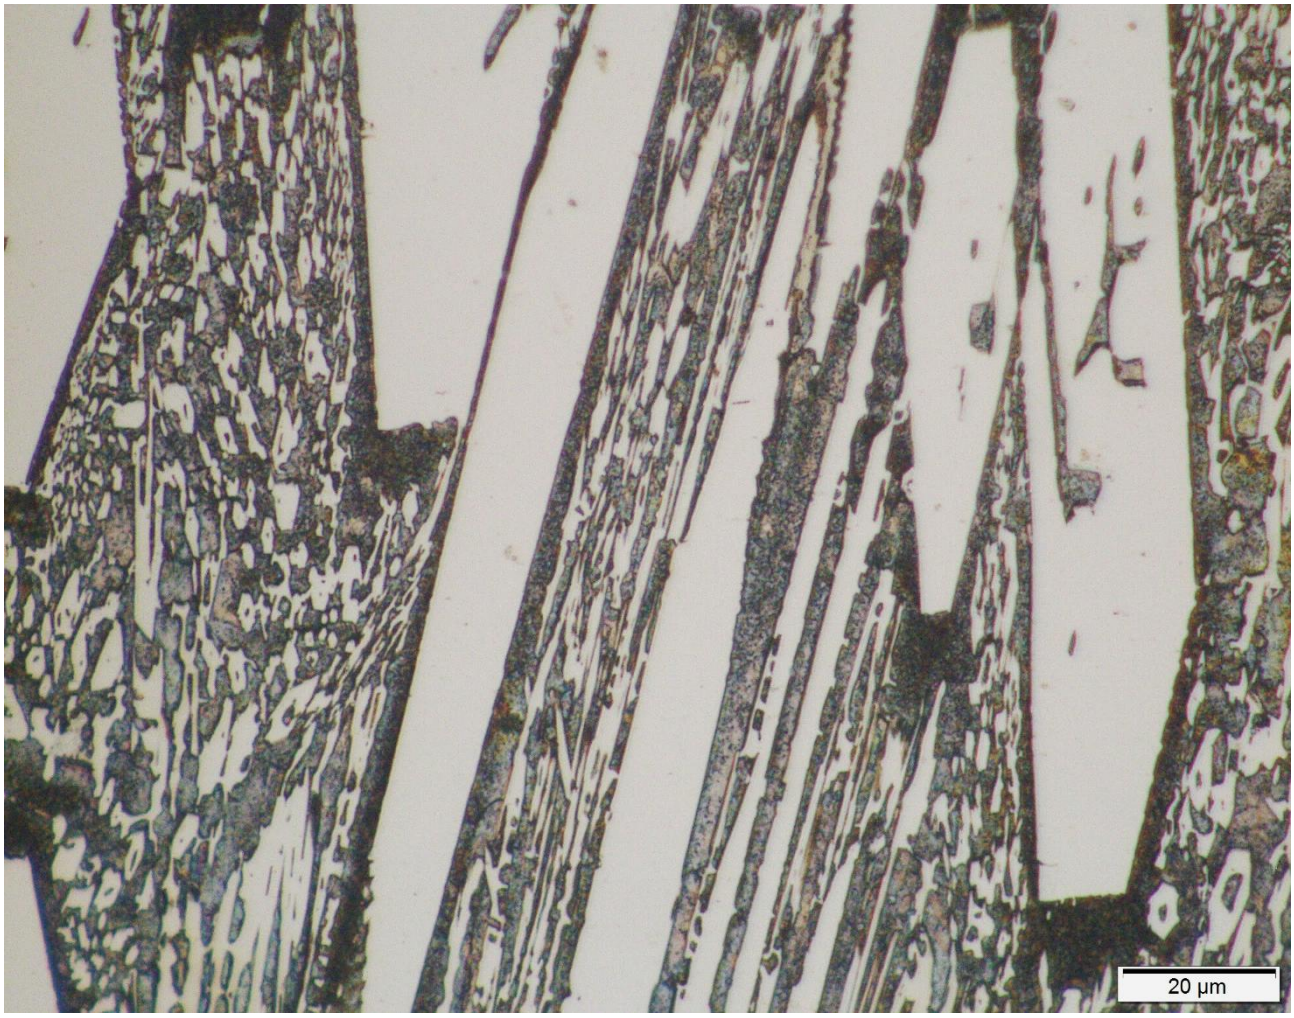
Figure 3. Microstructure at higher magnification.

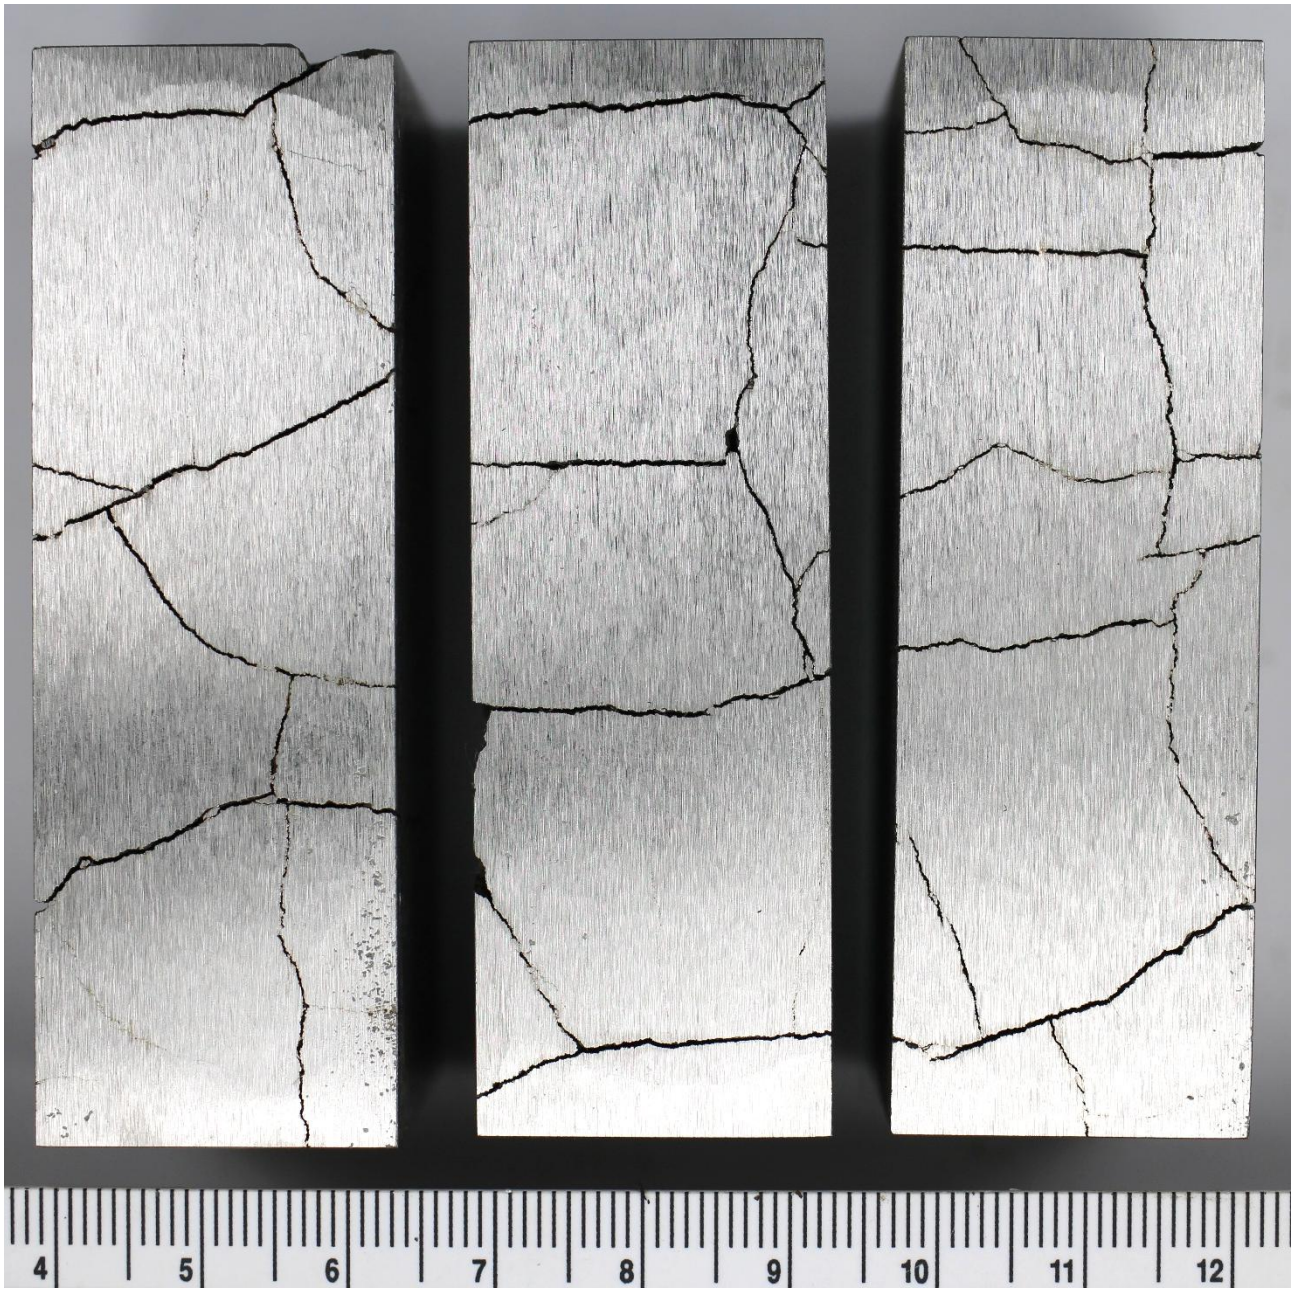
Figure 4. ASTM G65 specimens before testing (scale in cm).

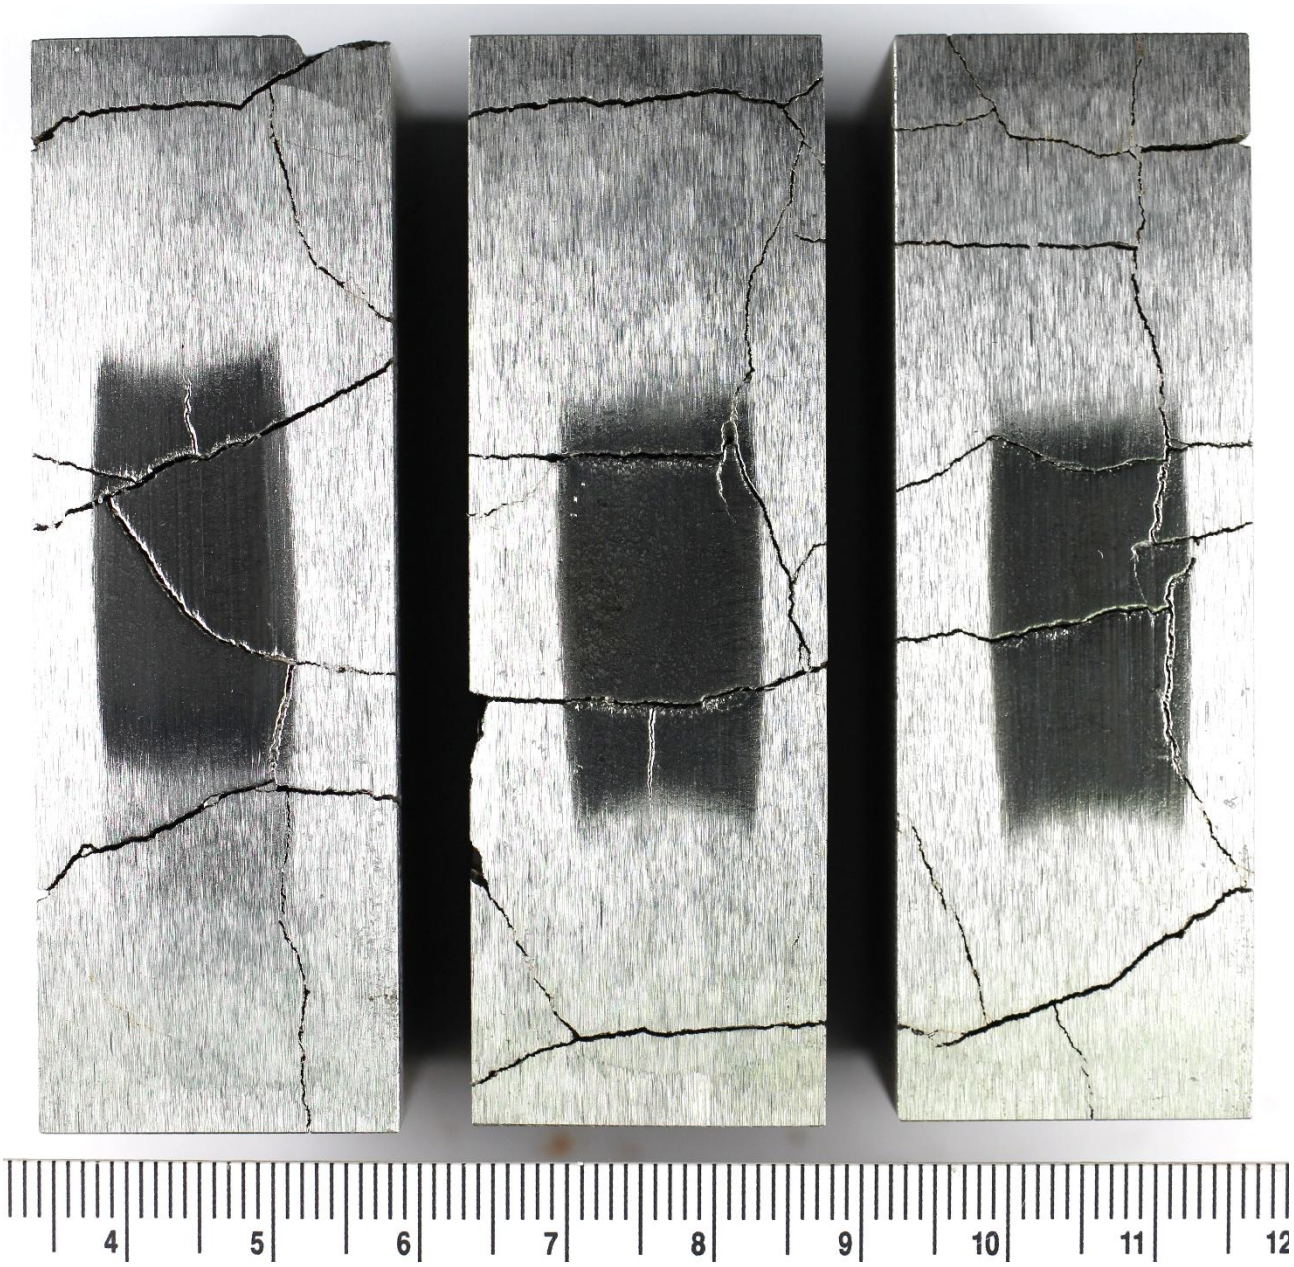
Sample ID		Specimen			Average
		1	2	3	
320N25	Mass loss	0.070 g	0.056 g	0.067 g	0.064 ± 0.007 g
	Volume loss	9.3 mm^3	7.4 mm^3	8.9 mm^3	8.5 ± 1.0 mm^3

Figure 5. ASTM G65 specimen wear scars after testing (scale in cm).
